# HYBRID QUADROTOR UAS SHIPBOARD OPERATION VIABILITY TESTING – LATITUDE ENGINEERING / NOAA

Latitude Engineering, LLC

21 June 2016

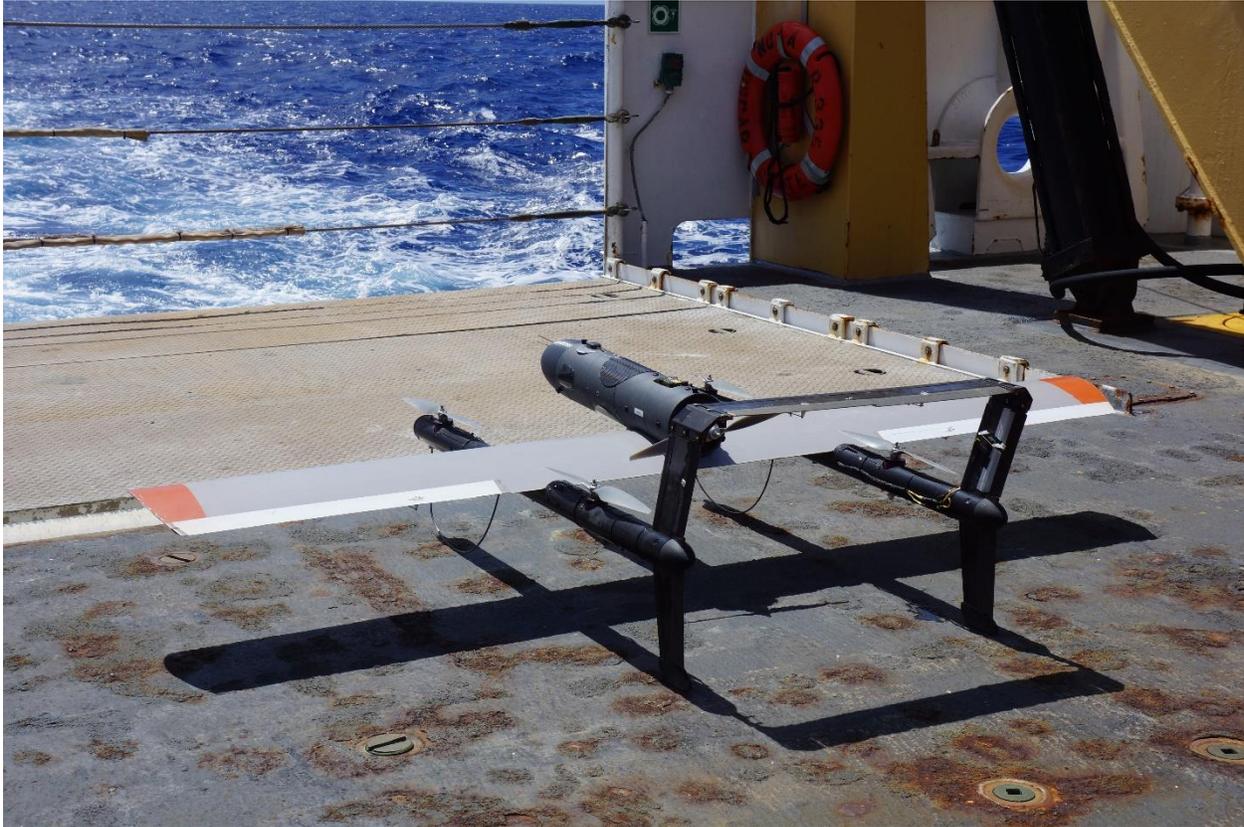
Latitude Engineering HQ-20

for flight control software development and high risk testing. For this test event, two HQ-20 aircraft were supplied by Latitude Engineering.
